Historic Timber Structures with Stainless Steel

Contributor: Marco Corradi

The use of stainless steel components, particularly in new constructions, has experienced a huge increase in recent times. Stainless steel is now widely used for both non-structural applications and as ribbed reinforcement bars for concrete, members (beams, columns, ties, etc.) in trusses, bridges and buildings. Similar to structural carbon steel, stainless steel elements can be hot rolled and fabricated or cold rolled formed.

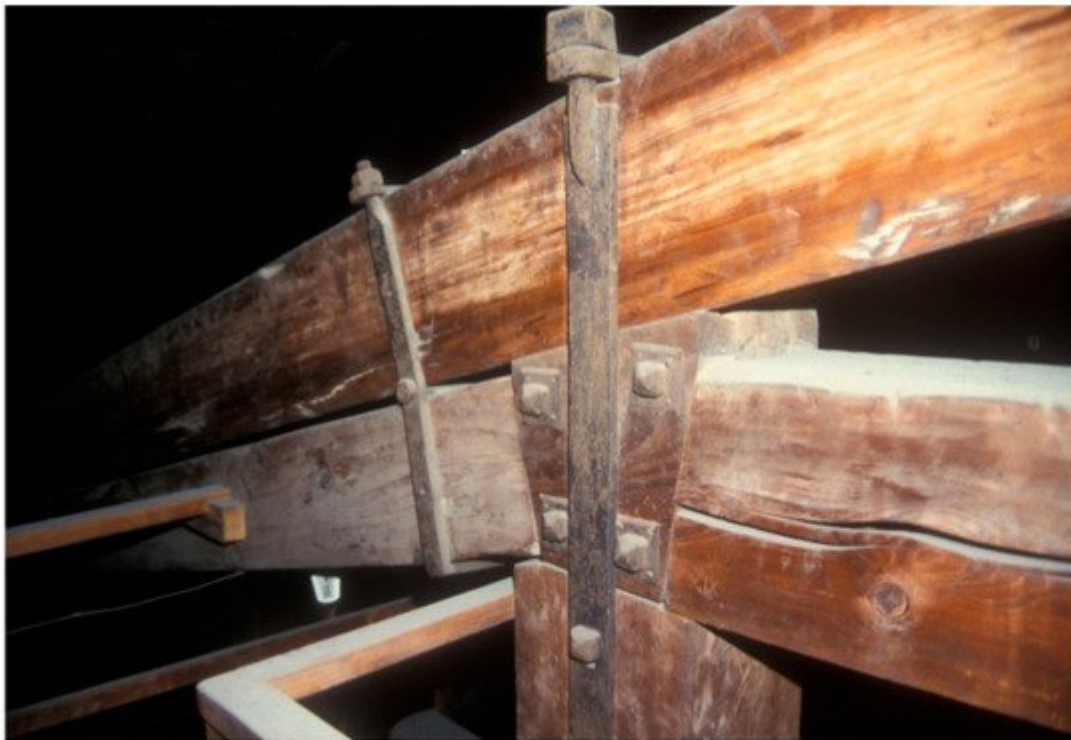
Figure 1. *Salone dei Cinquecento, Palazzo Vecchio, Florence, Italy:* Detail of timber roof structure and iron fasteners (the iron reinforcement is part of the original structure from 17th century).

The use of metal fasteners to reinforce local timber beams and trusses is a traditional technique (**Figure 1**). This was very common in the 19th and 20th centuries and it is still applied today [\[13\]](#)[\[14\]](#). The method simply consists in the application of one or more metal fasteners, made of metal strips, to prevent the slippage between two timber elements and increase the resisting section in critical areas. It is typically applied at the beam-to-temple connection points and in the timber-to-timber joints of the traditional king post roof trusses (**Figure 2**).

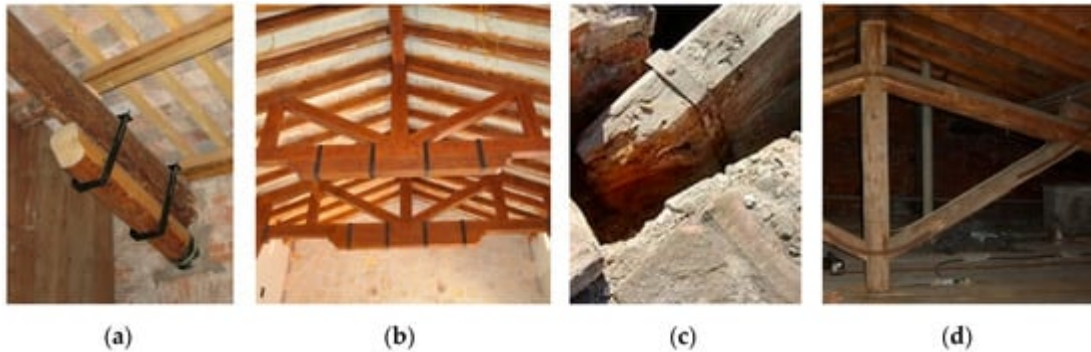
Figure 2. The traditional use of metal fasteners in critical sections of the timber beam floor and the king post roof truss: (a) timber template-beam (beam-floor); (b) joint king post-tie beam (truss); (c) joint strut-king post and principal rafter-king post (truss); (d) joint principal rafter-tie beam (truss).

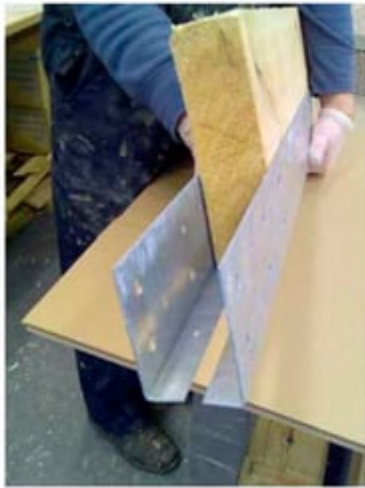
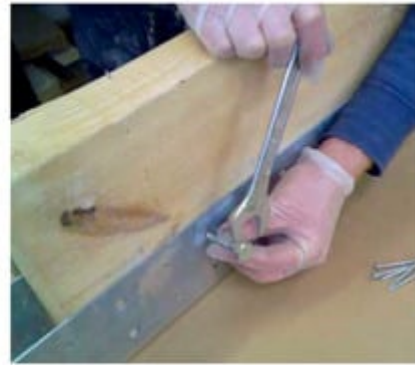
Figure 3. Re-construction of joist ends with stainless steel L-shaped profiles (press-bended stainless steel sheets) [\[16\]](#).

This one-way beam-floor is common in the UK, where it is still in use for new construction. To repair the joist ends from rotting at the point where the joists rest in brick or stone walls, pairs of stainless or galvanized steel plates, pre-drilled, are typically used with standard coach screws, which are secured at the end of degraded timber joists (**Figure 3**). The plates rest in or on the wall and allow for the rotted end to be cut off. To give additional stiffness, for use in rows of continuous end repairs, with no sound joist ends between. A bolted connection through the plates into the parent joist can be adopted [\[15\]](#)[\[16\]](#)[\[17\]](#).

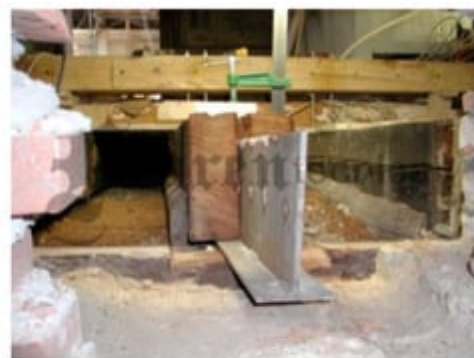
Figure 4. A stainless steel flitch plate inserted into a timber beam and bolted side-to-side: detail of the steel profile used at the beam ends [\[17\]](#)[\[18\]](#).

To reinforce the decayed timber beam ends, stainless steel flitch plates can be inserted along the beam length (**Figure 4**). This method involves cutting a slot into the timber and making the beam a composite of stainless steel and timber. The plate may also take a T-shape either the right way up (top of the beam) or upside down (underside of the beam). The steel flitch plate is best used at the underside of the beam and fixed upside down, so the wide part of the T is positioned to carry the highest tensile stresses. However, the functionality of the composite beam depends on the type of connection between steel and timber members. When reinforcement is carried out at the ends of simply-supported beams, connection should be able to transfer only the shearing forces (zero bending moment at the supports). In this situation, bolts in the stainless steel web are sufficient. From a practical viewpoint, these are difficult repairs to carry out on site, requiring overhead cutting of the slot by multiple drillings or chain-morticer/chain-saw cutting.

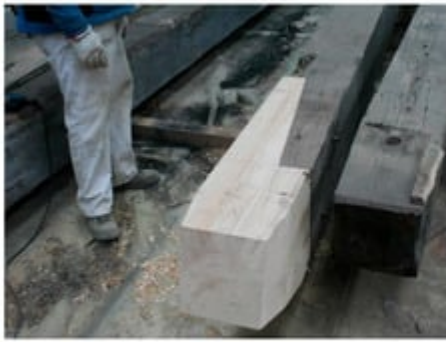
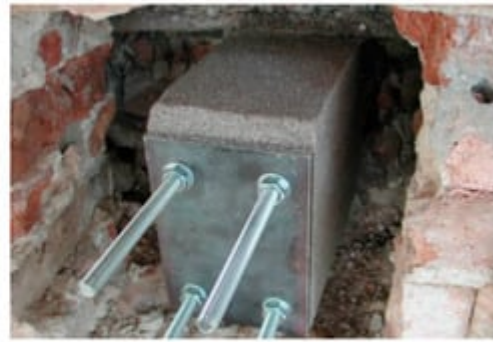
Figure 5. Re-construction of the beam ends: (a) stainless steel reinforced wooden prosthesis; (b) detail of the stainless steel reinforced epoxy prosthesis [\[21\]](#).

For repairing old solid timber beams, lintels or rafters, it is also common to use timber prostheses to connect with the damaged beam using smooth or ribbed stainless steel rods, connectors or bars. Holes are drilled, or a groove cut, in the undamaged pre-existing timber to accommodate the rod reinforcement. The prosthesis is usually made of a new, laminated structural timber (**Figure 5**), made in kiln dried wood or epoxy paste (using construction shutters). The rods are typically made of fiberglass, carbon FRP or stainless steel (**Figure 6** and **Figure 7**). Pouring or injection resins are used to fix the rods into the prostheses and the pre-existing beam [\[18\]](#)[\[19\]](#)[\[20\]](#)[\[21\]](#).

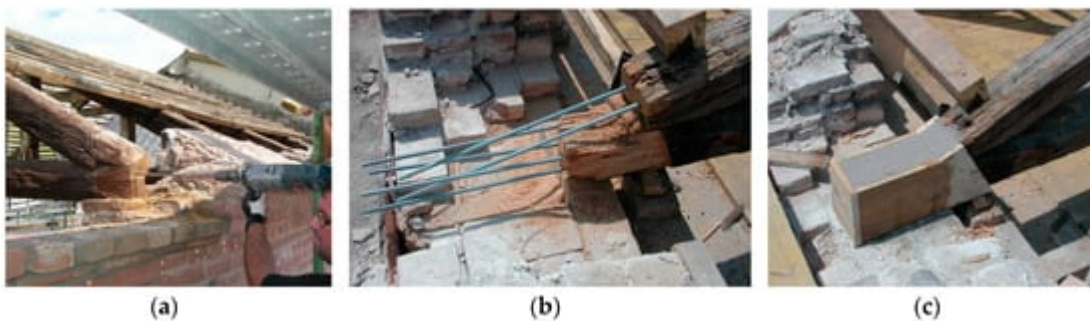
Figure 7. Re-construction of tie or rafter ends with stainless steel rods [\[18\]](#): (a) drilling the holes for rod installation; (b) insertion of the stainless steel rods; (c) resin casting.

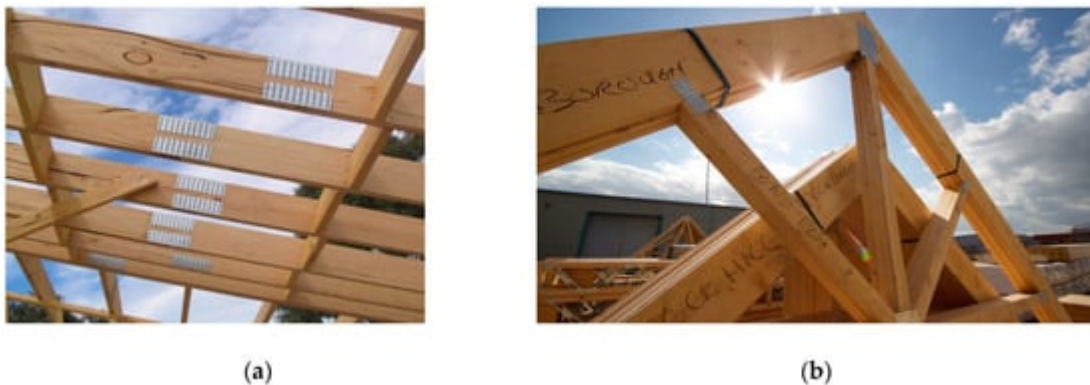
Figure 8. Examples of connections made with nail-plates [\[24\]](#)[\[25\]](#).

Although the use of nail plates can be considered a versatile and cost-effective method to improve the connection between wood elements (**Figure 8**), their use for historic or listed timber structures is rare and not often authorized by conservation bodies. This is mainly due to the fact that a nail-plate connecting system can cause damage to the timber structure, and facilitate biotic attack by saprophytic insects and fungi. For historic structures, it is always preferable to repair/restore the pre-existing historic connecting devices (post-and-beam, tie-and-rafter and other construction techniques). Furthermore, nail-plate connections are rarely able to transfer to maximum allowable internal force from one element to another [\[22\]](#)[\[23\]](#).

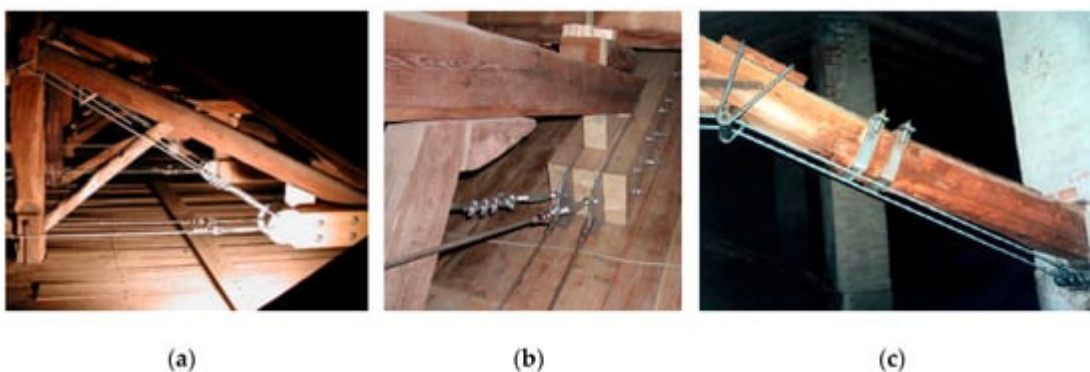
Figure 10. Reinforcement interventions using stainless steel wire ropes (design, Prof. L. Jurina): (a) and (b) Residence Masciadri in Arcene, Italy; (c) Residence Masciadri in Arcene, Italy [\[28\]](#).

Figure 10 shows different retrofitting interventions, designed by professor L. Jurina [\[27\]](#). The use of stainless steel wire ropes may represent an interesting solution when the reinforcement is exposed and unprotected. The installation of the ropes is relatively easy, the intervention is reversible, and the damage to the timber structure is very limited. However, particular attention should be given to stress concentration problems at the rope-timber joints and it is recommended to take periodic measurements of the creep deformation of the stainless steel ropes. The joint between the wire rope (tie) and the timber rafter is made using two steel plates (**Figure 10b**). These are inserted into a glulam element connected to the diagonal timber rafter with a bolted connection. The wall-to-wire connection can be effectively realized using anchor bolts (**Figure 10c**).

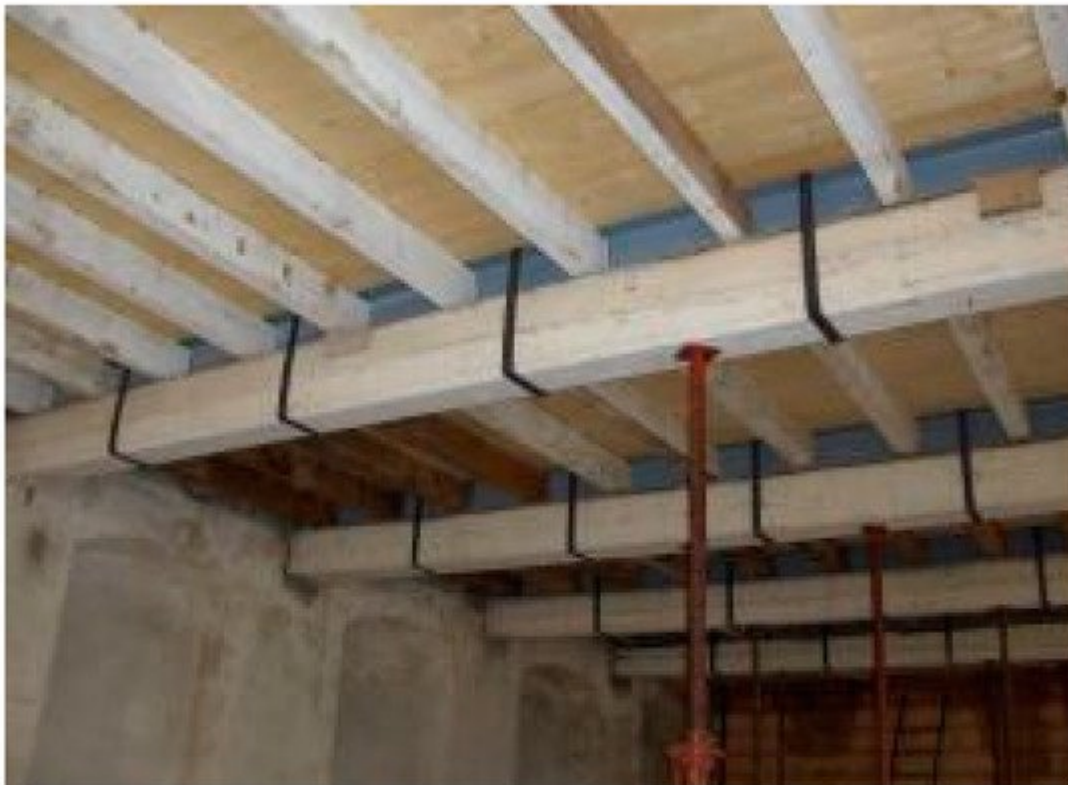
Figure 11. Reinforcement of a timber beam using a stainless steel H-shaped beam applied on the compressed area.

When conservation bodies or local authorities do not authorize retrofitting interventions, on listed buildings, at beam intrados (under the timber beams), for example, for the presence of decorations, it is possible to effectively reinforce timber-beam floors by operating on the beam extrados (over the beams) [31] (**Figure 11** and **Figure 12**). In fact, to increase both the bending capacity and stiffness characteristics of existing wood beams, the use of stainless steel profiles placed in the compression side is an interesting solution. Stainless steel elements do not function as a substitute for the timber beams but rather effect an increase in their capacity and flexural stiffness through the creation of a mixed timber–stainless steel structure [32]. The application of stainless steel profiles can be done using epoxy resins, fasteners and/or metal screws or bolts. The use of mechanically attached connectors (screws or bolts) is usually preferred, given the high stress level, under loading, at interface between the timber beam and stainless steel beam. Stainless steel profiles can be also notched to better accommodate the floor joists, without highly affecting the effectiveness of the steel reinforcement. Furthermore, it should be noted that the reinforcement can be completely invisible behind the timber beams, it does not cause significant damage to the timber beams, and it can be easily removed, if needed, providing the method with reversibility characteristics. The reinforcement with H-type elements is characterized by this property and by high machinability of stainless steel elements to be carried out on-site. The reinforcement of timber beams using stainless steel beams is capable of resulting in a significant increase in strength, stiffness, and ductility and the application of the reinforcement is extremely fast and effective.

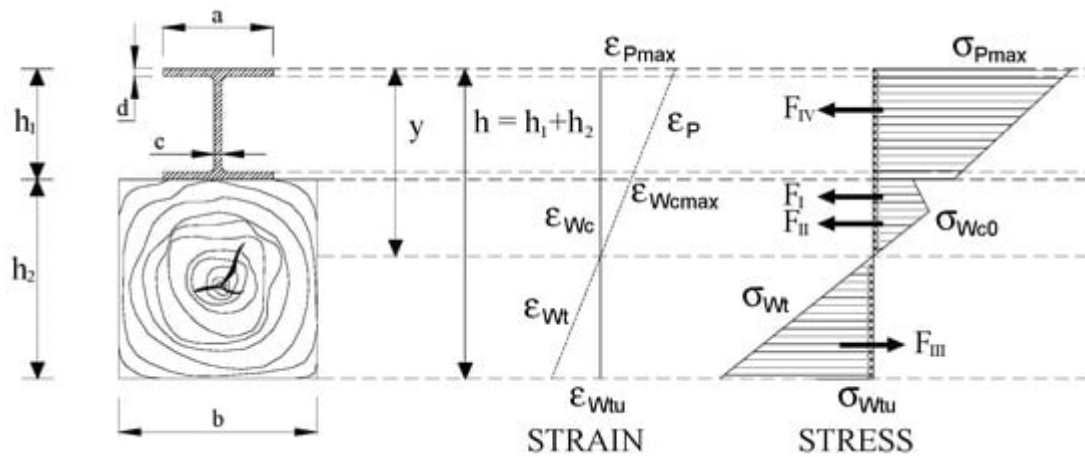
Figure 12. Reinforced timber beam cross section: stress and strain distribution, after timber yielding in compression. Reproduced from [31], with permission from Elsevier, 2007.
