Earthquake Reconnaissance Data

Earthquakes are one of the most catastrophic natural phenomena. After an earthquake, earthquake reconnaissance enables effective recovery by collecting data on building damage and other impacts. This paper aims to identify state-of-the-art data sources for building damage assessment and provide guidance for more efficient data collection. We have reviewed 39 articles that indicate the sources used by different authors to collect data related to damage and post-disaster recovery progress after earthquakes between 2014 and 2021. The current data collection methods have been grouped into seven categories: fieldwork or ground surveys, omnidirectional imagery (OD), terrestrial laser scanning (TLS), remote sensing (RS), crowdsourcing platforms, social media (SM) and closed-circuit television videos (CCTV). The selection of a particular data source or collection technique for earthquake reconnaissance includes different criteria depending on what questions are to be answered by these data. We conclude that modern reconnaissance missions cannot rely on a single data source. Different data sources should complement each other, validate collected data or syste

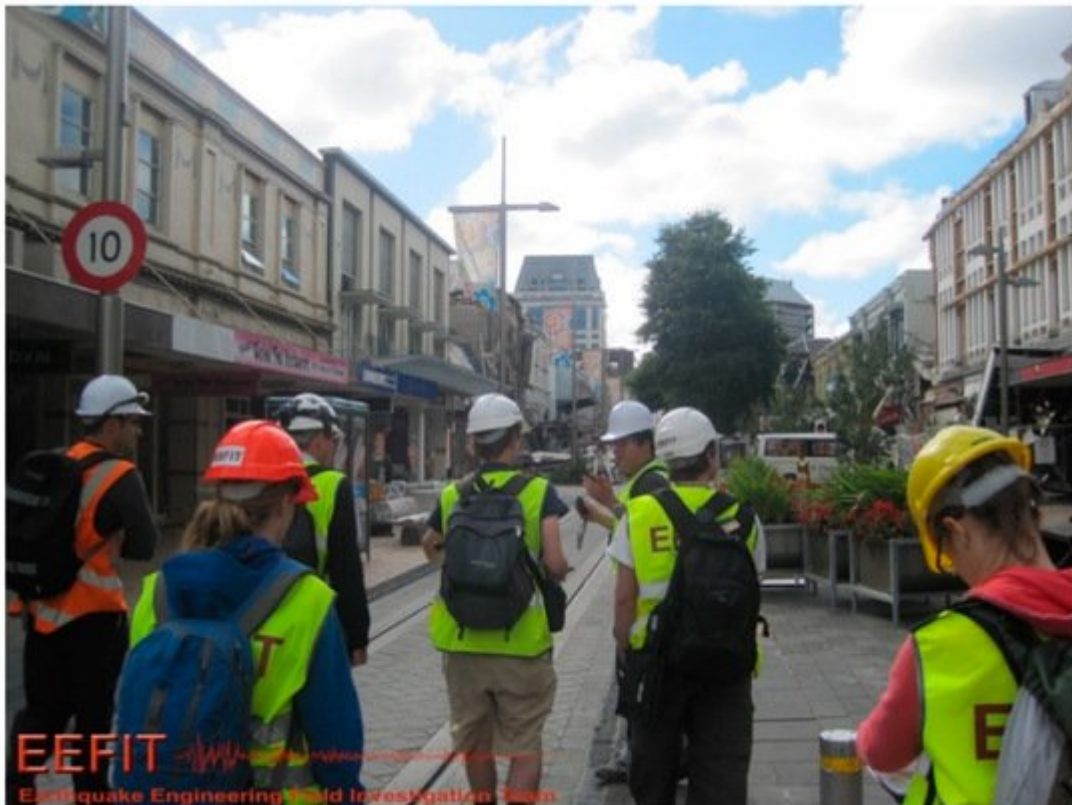
Figure 1. EEFIT earthquake reconnaissance mission after the Christchurch earthquake in 2011. Source: [38].

In a foot-on-ground survey, as it is portrayed in **Figure 1**, the assessment is conducted manually [35], one building after another [25]; each reconnaissance mission in the field takes approximately one week. Considering that, there is a preliminary data collection to limit the inspection area where the causes of failures of buildings can be observed within a safe environment. Earthquake reconnaissance missions' members are usually trained volunteers

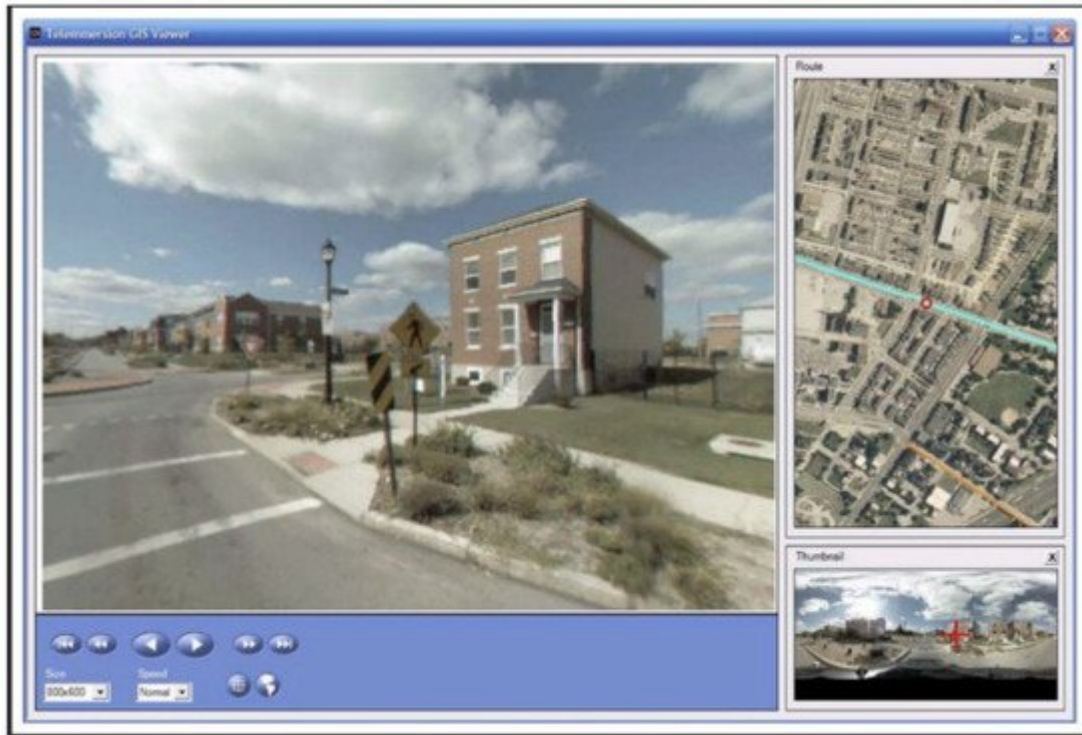
Figure 2. A portion of an OD image depicting a street intersection in St. Louis, MO. Source: [\[40\]](#).

The outcomes of the fieldwork or ground surveys can be improved by the unique viewpoints and perspectives delivered by the OD camera technology. Employing OD cameras enables the collection of chains of omnidirectional images. The development of online platforms to host the collected images makes it possible for those photo chains to be easily visualized to simulate an immersive 'walk through' of a landscape with a 360 degree view, ideal for comprehensive damage inspections in reduced access zones [27]. One example of the visualisation obtained with this technology is presented in **Figure 2**.
